(NASA-CR-144267) REMOTE MEASUREMENT
UTILIZING NASA'S SCANNING LASER DOPPLER
SYSTEMS. VOLUME 1. LASER DOPPLER WAKE
VORTEX TRACKING AT KENNEDY AIRPORT Final
Report (Lockheed Missiles and Space Co.)

Remote Measurement Utilizing NASA's
Scanning Laser Doppler Systems

Volume 1 - Final Report

Laser Doppler Wake Vortex Tracking
at Kennedy Airport

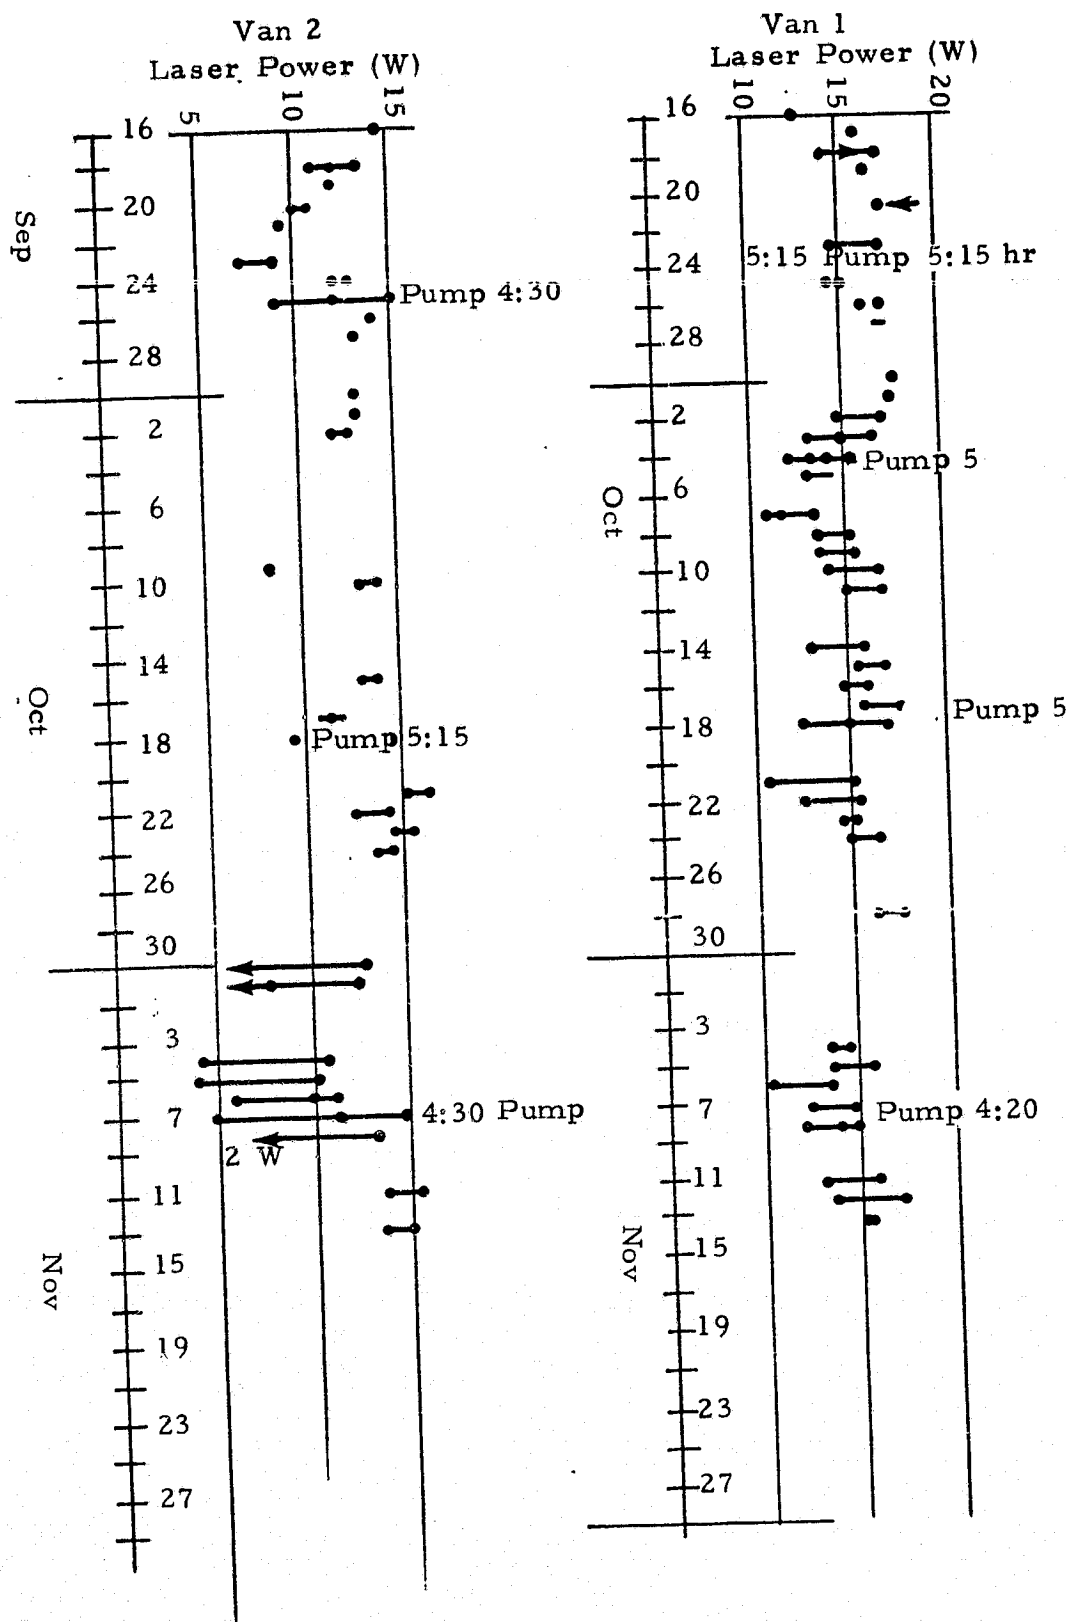
optical adjustment by the operator to maintain its alignment and keep its power within acceptable limits. Performance of the laser in Van 1 was, in general, considerably superior to the unit in Van 2 in both power output and power stability, however, both were found to fluctuate by as much as $\pm 15\%$ over several hours operation. Figure 7 presents plots of power fluctuation. As long as a qualified operator is present to maintain both laser and optical systems alignment, the laser presently in use is satisfactory although not optimum. If, however, an unattended system were envisaged, the present laser is totally unsatisfactory.

Current fluctuation problems developed with a laser power supply in Van 2 and were partially corrected when a resistor was replaced in the voltage range adjustment switch. This repair improved current stability (and hence laser power stability), but did not entirely remove the current fluctuations. A new power supply was installed. Problems occurred also with this supply. Later it was discovered that the major problem was arcing in the high voltage multi-pin connector at the base of the power supply rack.

Fig. 7 - LDV Laser Power Measured at Secondary - Maximum and Minimum During Each Day of Operation for Period Indicated
